**THE UNITED STATES AIR FORCE  
INSTALLATION RESTORATION PROGRAM**

**FIVE-YEAR ROD REVIEW REPORT**

**EIELSON AIR FORCE BASE, ALASKA**

**JANUARY 2004**

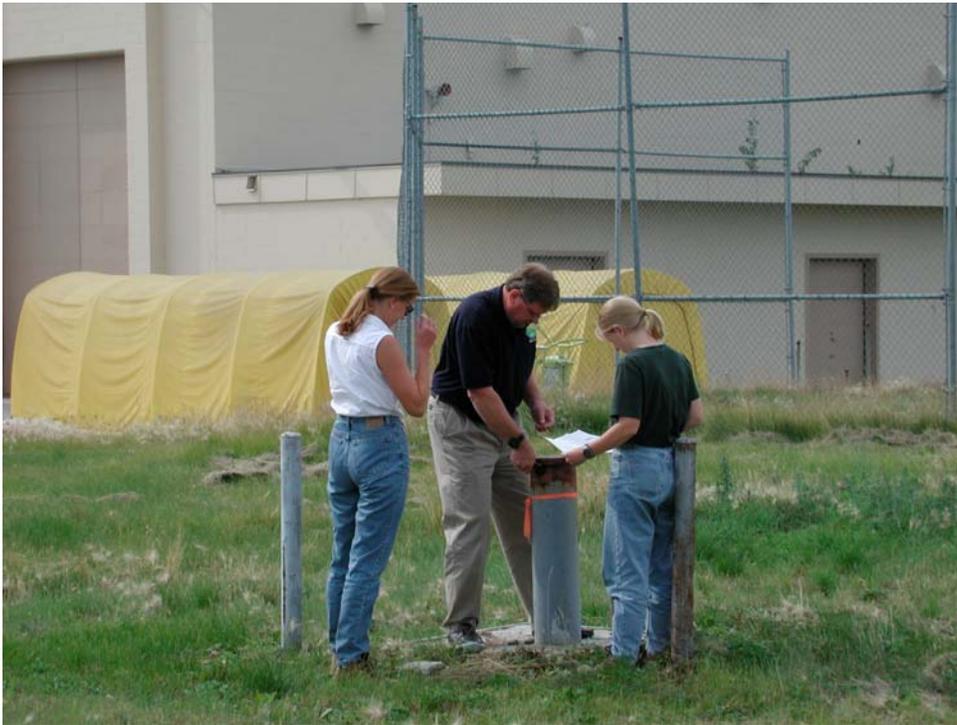
Photo 1: Site inspection team discussing monitoring well locations and sample results for site WP45/SS57. The inspection team includes USAF, USEPA, and ADEC representatives, by EA Engineering staff.

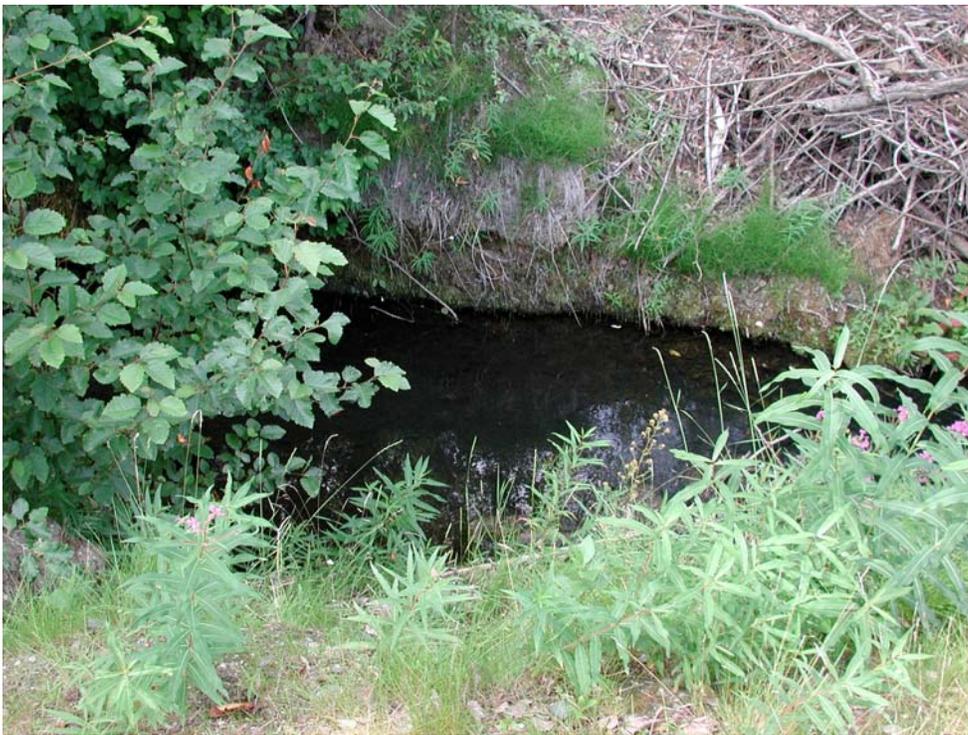
Photo 2: Garrison Slough exiting the Water Treatment Plant Pond at SS35.

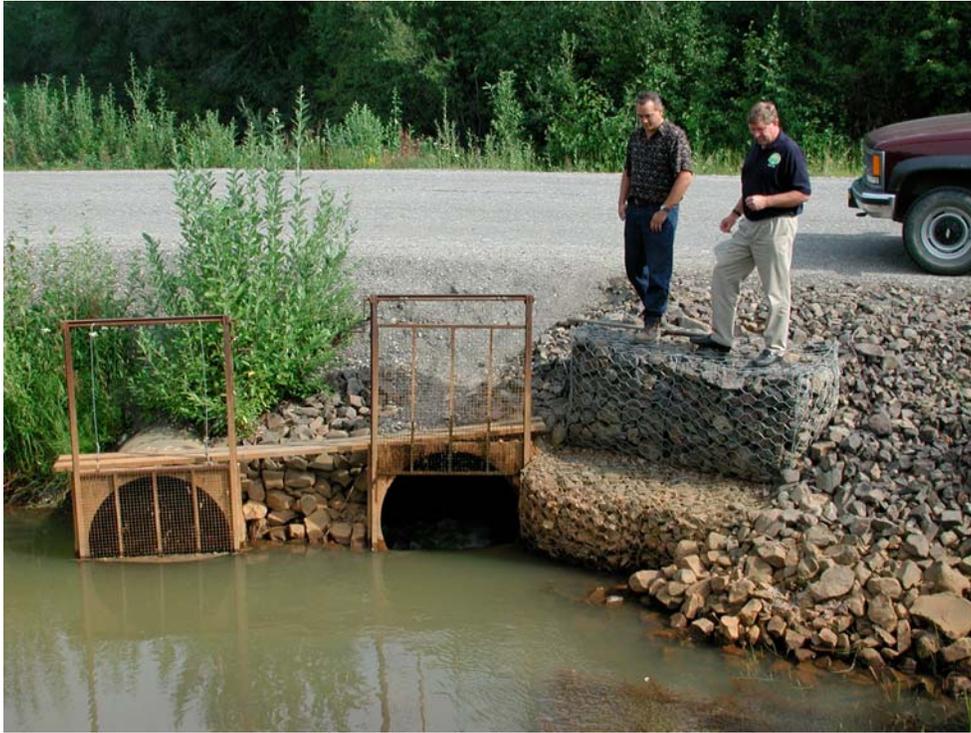
Photo 3: Fish screens along Garrison Slough.

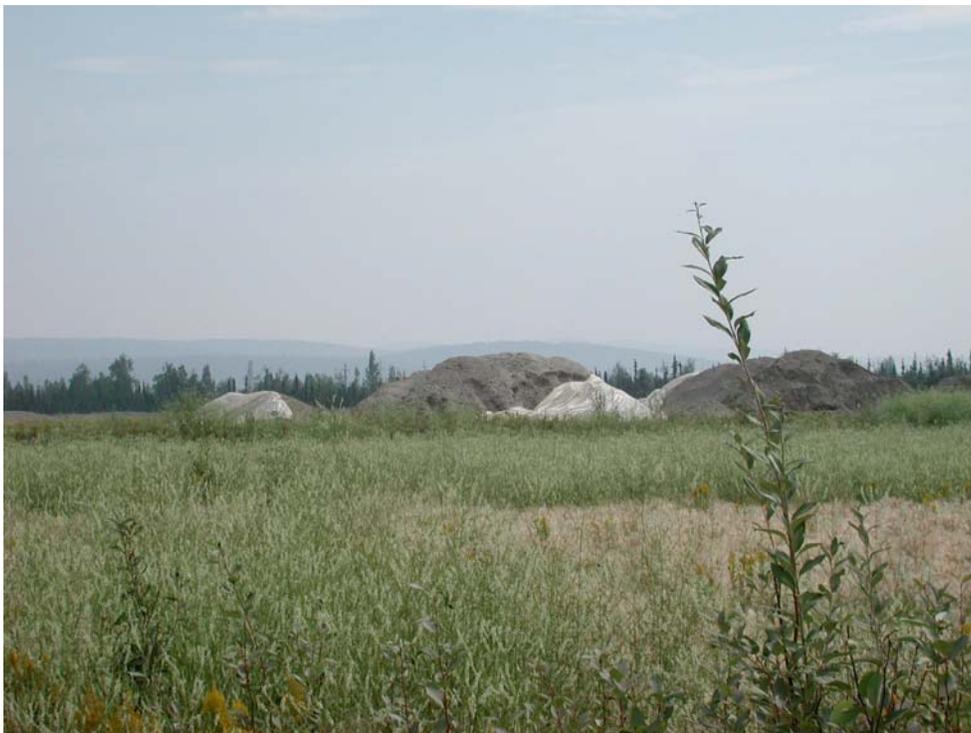
Photo 4: Containment cells storing POL impacted soils at LF03.

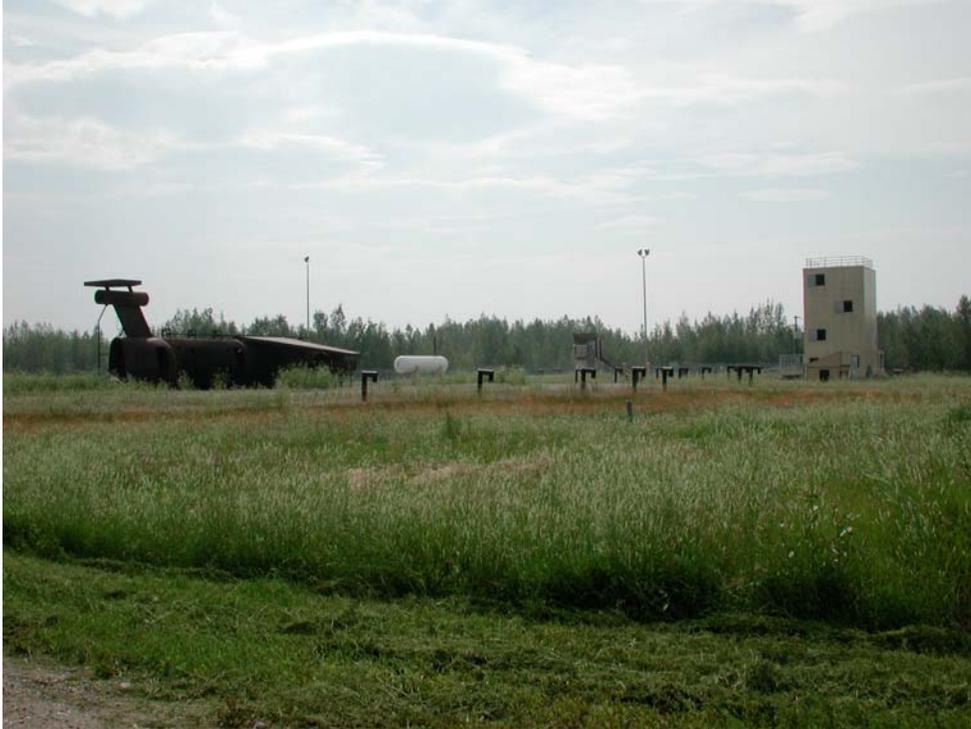
Photo 5: Fire Training Facility at FT09.

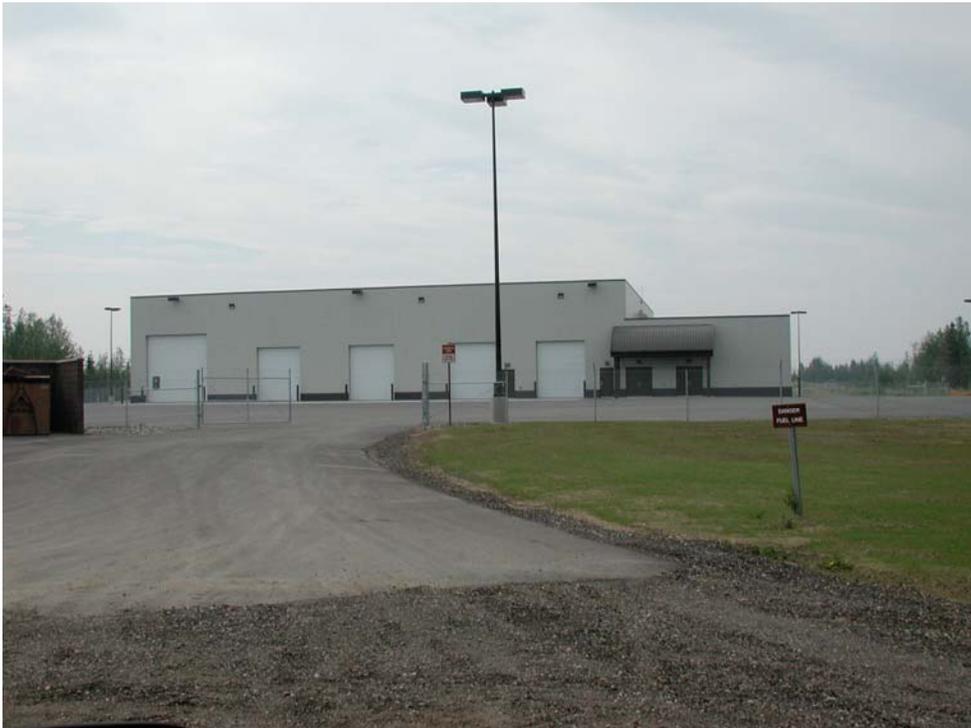
Photo 6: Munitions storage facility constructed at LF03.

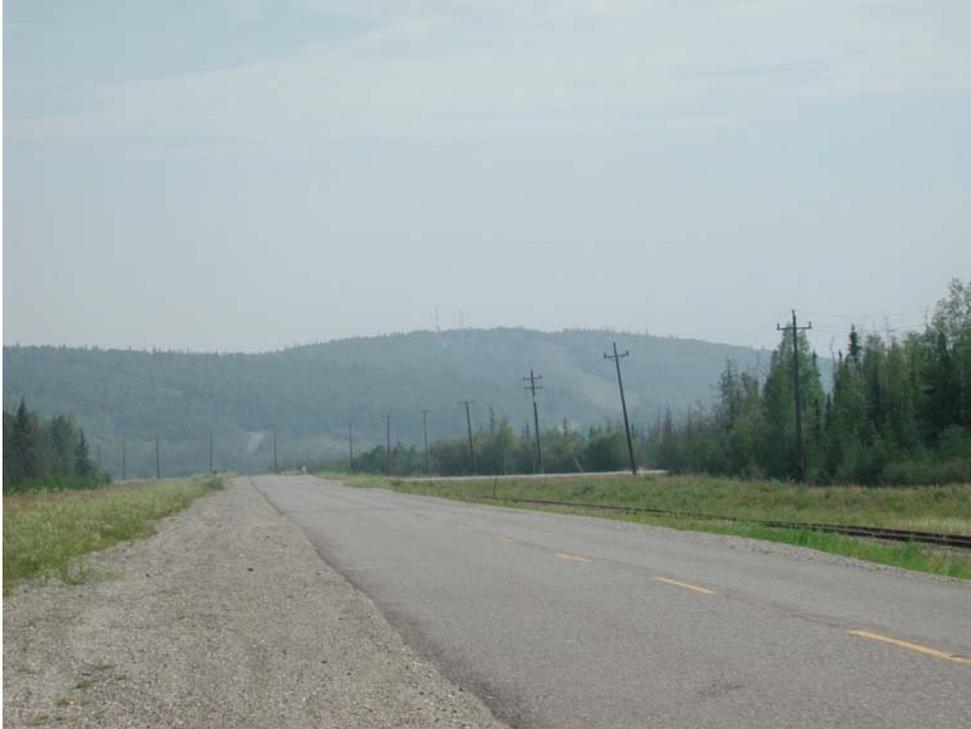
Photo 7: Looking north at WP38.

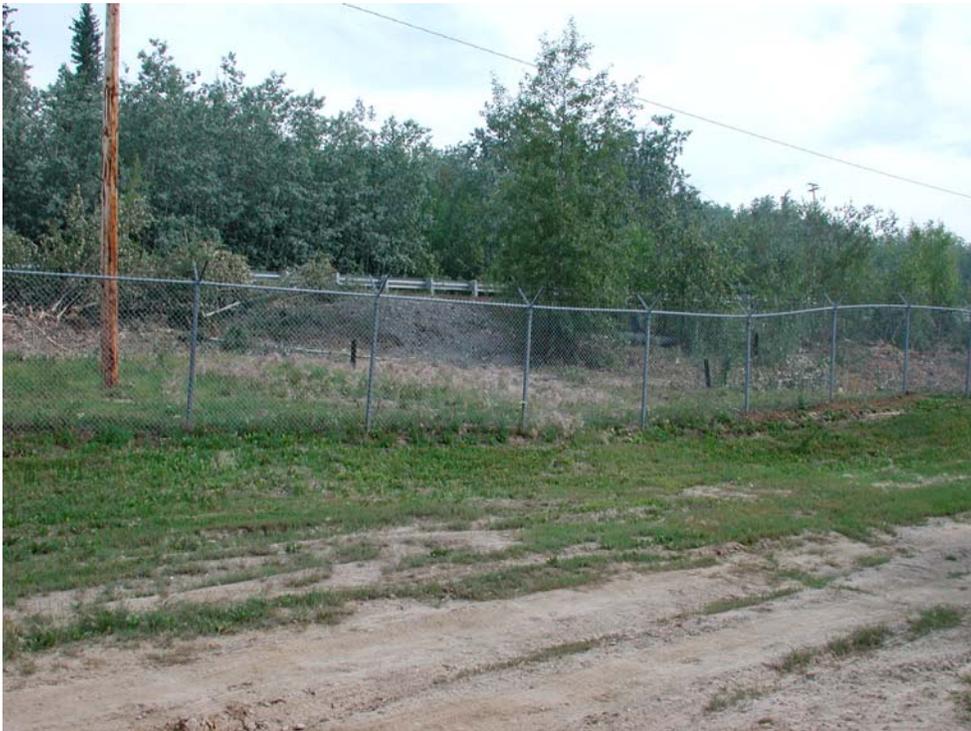
Photo 8: Engineer Hill (ST56) septic system location.
